Manhole Inspection Summary

Manhole # S53K__056MH

Location Address: **3210 foster**

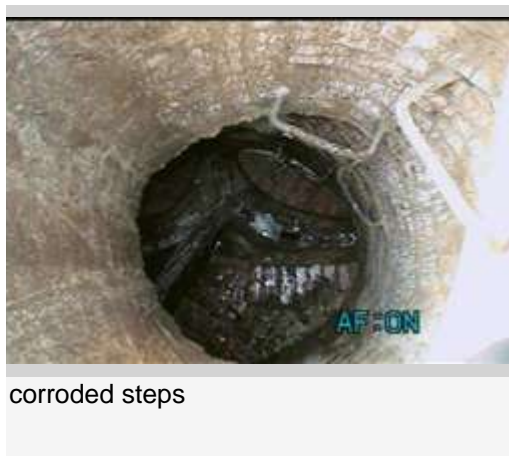
Defect 1

Steps Count: **4** Missing: **0** ☒ **Corroded**

corroded steps

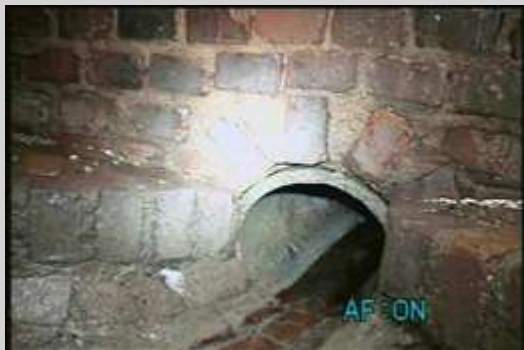
12 O'Clock Outflow

8 in. Circular Gravity Sewer
Pipe Out @ 12 O'Clock

Pipe Material: **Clay** ☐ Pipe Lined

Invert Depth: **10.25** (ft.) Flow Characteristics: **Fast**

Deposits: ☒ None ☐ Mud ☐ Sludge ☐ Debris ☐ Grease

Infiltration: **None** Pipe Seal Cond: **Unknown**

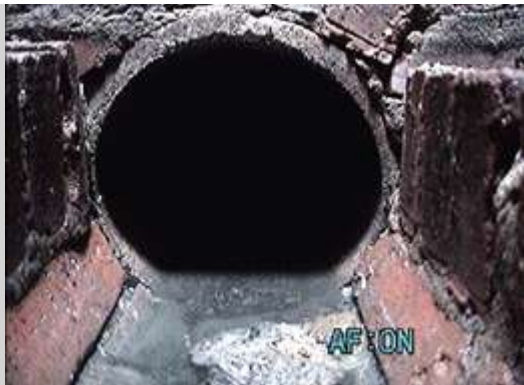
3 O'Clock Inflow

8 in. Circular Gravity Sewer
Pipe In @ 3 O'Clock

Pipe Material: **Clay** ☐ Pipe Lined

Invert Depth: **9.83** (ft.) Flow Characteristics: **Fast**

Deposits: ☒ None ☐ Mud ☐ Sludge ☐ Debris ☐ Grease

Infiltration: **None** Pipe Seal Cond: **Unknown**

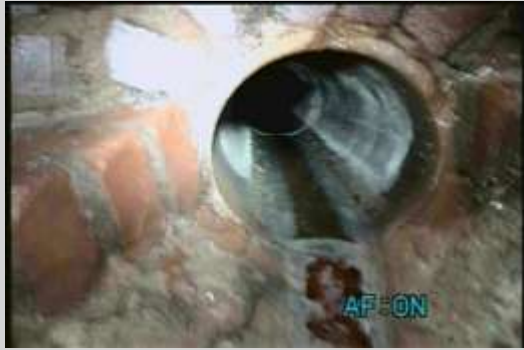
7 O'Clock Inflow

6 in. Circular Gravity Sewer

Pipe Material: **Clay** ☐ Pipe Lined

Invert Depth: **9.82** (ft.) Flow Characteristics: **Fast**

Deposits: ☒ None ☐ Mud ☐ Sludge ☐ Debris ☐ Grease

Infiltration: **None** Pipe Seal Cond: **Unknown**

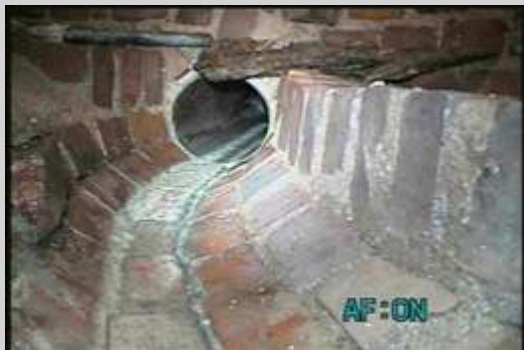
9 O'Clock Inflow

8 in. Circular Gravity Sewer

Pipe Material: **Clay** ☐ Pipe Lined

Invert Depth: **10.00** (ft.) Flow Characteristics: **None**

Deposits: ☒ None ☐ Mud ☐ Sludge ☐ Debris ☐ Grease

Infiltration: **None** Pipe Seal Cond: **Unknown**

Connects To: **House connection / Service line**
